WIND TURBINES LIGHTNING PROTECTION

4. PRESENTATION OF THE DAMAGE OF THE WIND TURBINE OF 0,5 MVA

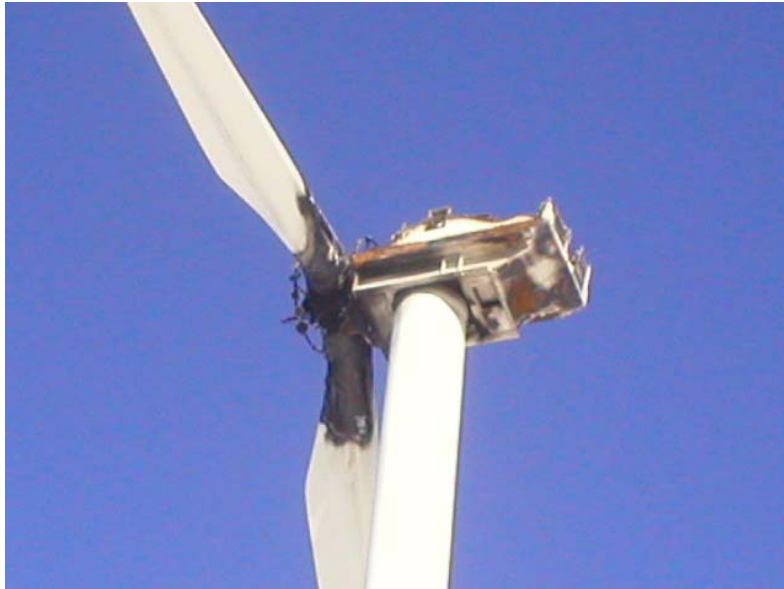
Wind turbine placed at place Vilusi was manufactured in 1997, before the IEC technical report concerning lightning protection was published. It was not equipped with any lightning protection system, except a small lightning rod above the generator, about 20 m below the blade tip when it is in vertical position. It was mounted in October 2004, but it was not in operation because it was not technically accepted. In January 1995 during snowstorm it was a strong thunderstorm. A lightning strike to one blade of wind turbine happened. It damaged completely one blade, which fall down, like in Figure 7.

Figure 7: Wind turbine without one blade struck by lightning

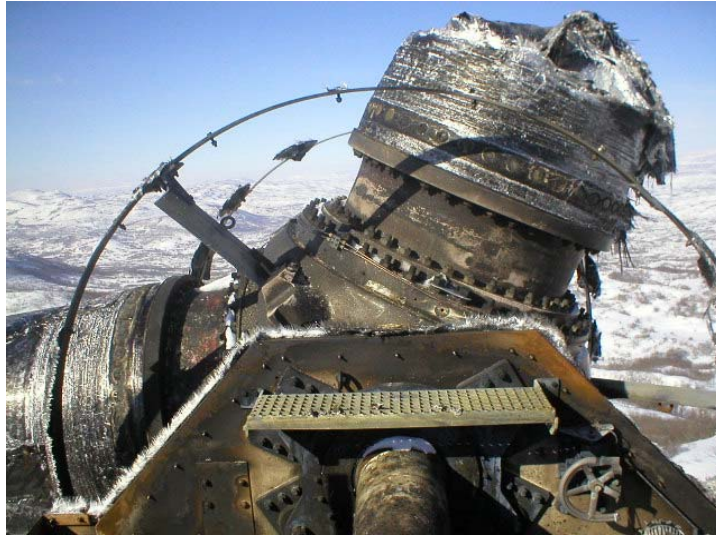
In Figure 8 the blade root of the damaged blade is presented. It can be seen that a strong fire completely destroyed hub.

Figure 8: Destroyed wind turbine hub

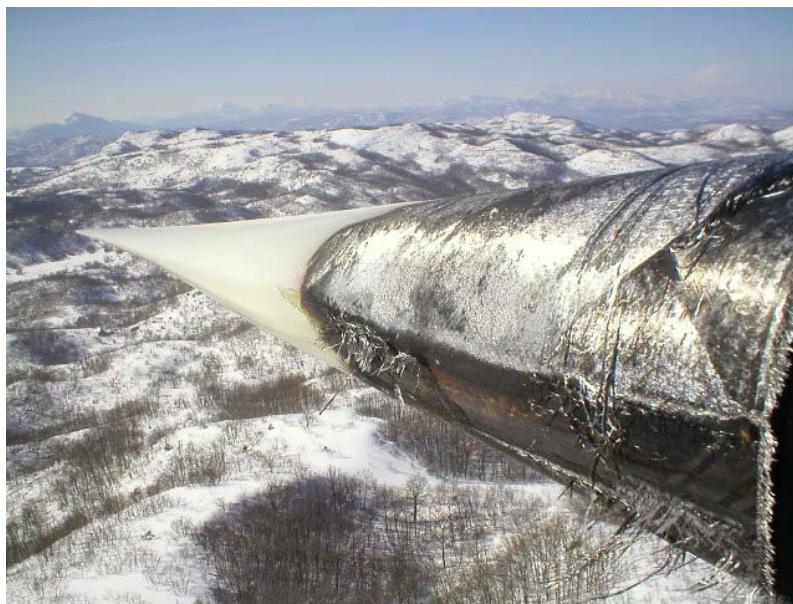
Other blades have damaged surfaces couple of meters from hub, like in Figure 9.

Figure 9: The damaged surfaces of the other blade

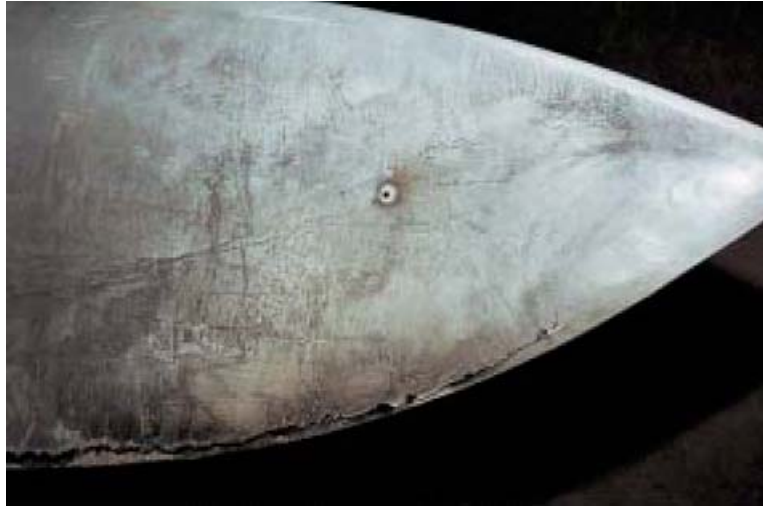
The hit blade found at ground has a small entrance hole nearly without damage at surfaces. Going to the blade root the damage increased, melting the inside material of the blade, separating blade sides due to the high pressure and producing stronger fire closer to the blade root. In Figure 10 the entrance hole is presented.

Figure 10: Entrance hole at blade surface

It was found that the main reason of wind turbine damage was the absence of any lightning protection system at the blades. No damage to low voltage installation and equipment in tower base and in transformer substation was found.
