DISTRIBUTION NETWORK EVENTS ANALYSIS WITH TOOLS PROVIDED BY MODERN SYSTEMS OF DIGITAL PROTECTION

A. Milosavljević, Elektrodistribucija Beograd, Serbia
R. Vladetić, Elektrodistribucija Beograd, Serbia
V. Cvetković, Elektrodistribucija Beograd, Serbia

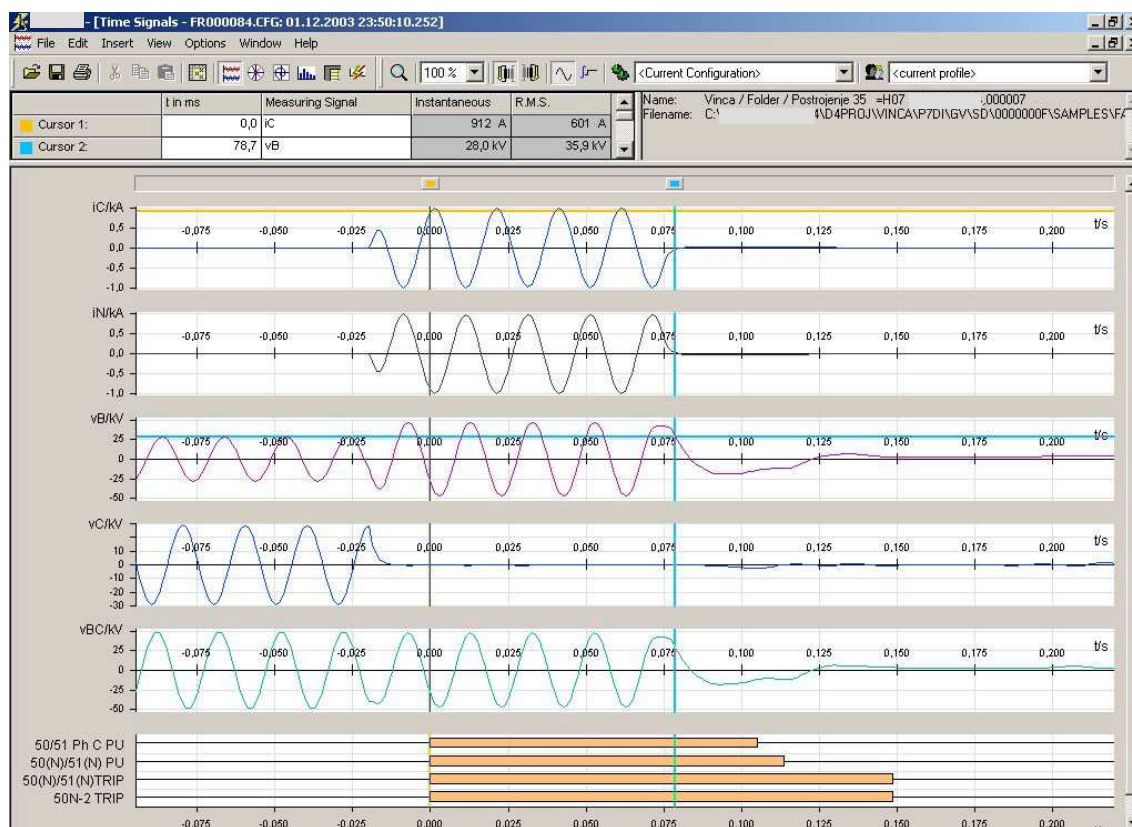
Picture 1

First event that we talk about happened in TS Vinča on the 1st of December 2003 in the 35kV feeder bay H07. The isolation breakdown occurred on the cable head and earth fault developed on the C phase. By using software for fault analysis and data stored in the relay protecting the feeder, we can see the time sequence of the fault and check the value of any variable in the system (picture 1).

This program packet enables straightforward summary of voltage and current time signals in the faulty and healthy phases as well as relay protection activity diagram. We can see clearly the loss of voltage in the C phase, raised voltage in the healthy phase and the moment of circuit breaker contacts opening, i.e. fault clearance. Any variable value in any moment of the time record can be read out using two available cursors. Picture 2 represents over current relay trip log record for this fault. From trip log it is possible to analyze the event and protection relay performance even more thoroughly.

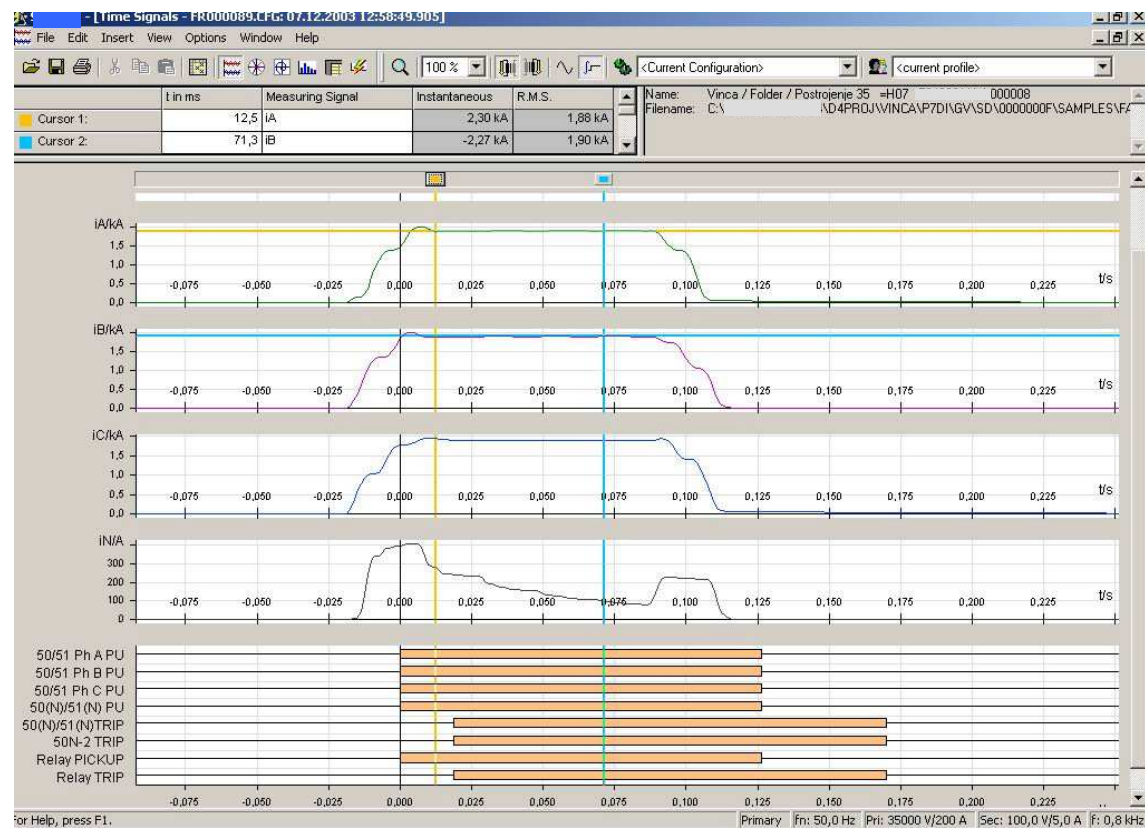
Picture 3

In the picture 3, time sequence for three-phase short circuit can be seen. The fault occurred in the same bay, H07 when earthing disconnect mechanical failure lead to energized busbars being directly grounded. RMS values of the currents are shown on the diagrams.

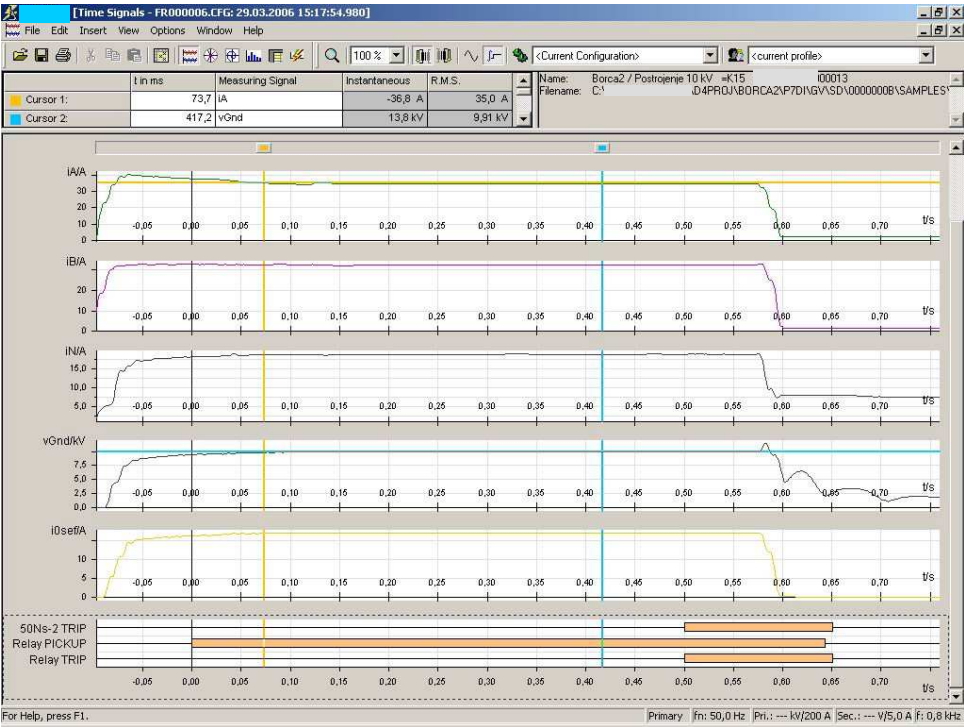
The fault developed as a multiple short circuit probably caused by tree branch contacting overhead line. Due to the fact that the 10kV power network in this substation is isolated, and that short circuit path involved high fault resistance, sensitive earth fault element of the protection relay picked up and

tripped. The relay started auto-reclose sequence. Picture 5 depicts initial fault and protection reaction with set time delay. Picture 6 shows continued fault after circuit breaker closed following first dead-time, and picture 7, second auto-reclose cycle and final breaker opening. Picture 8 shows trip log record for this event.

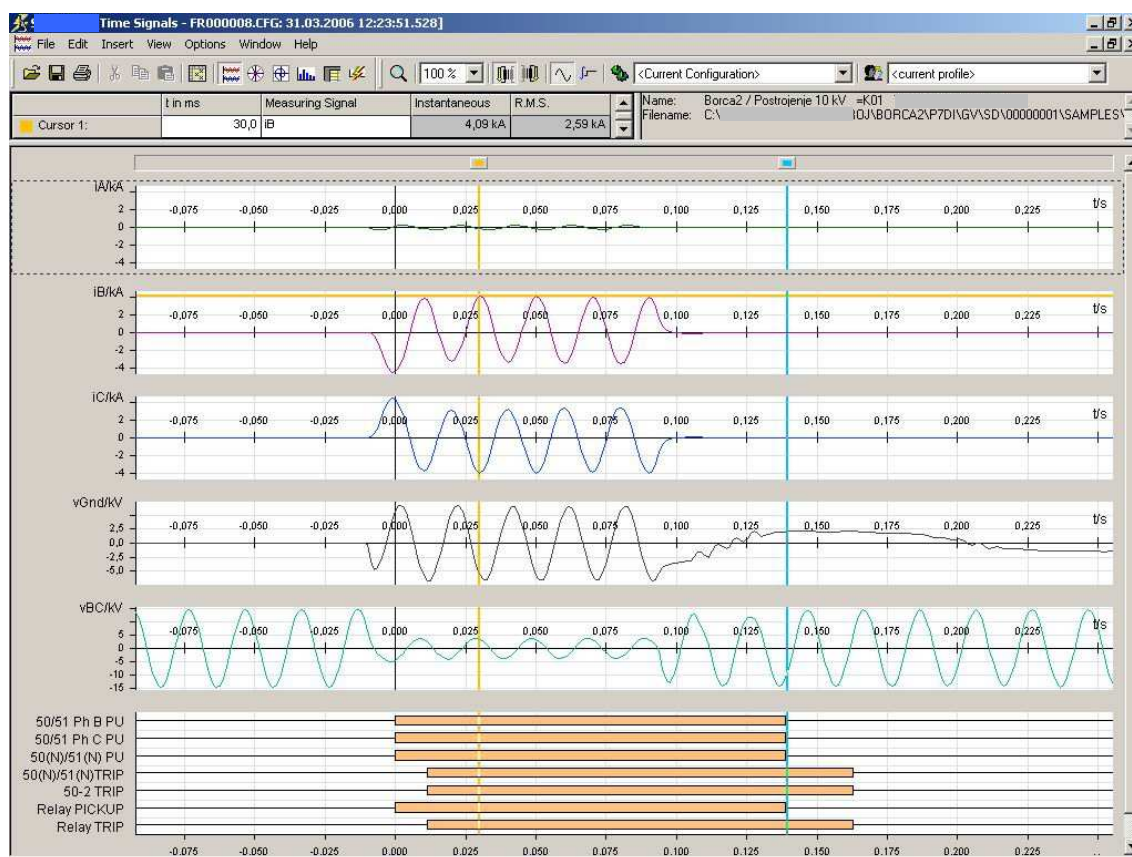
Picture 10

Another event from this substation happened when the circuit breaker in the K01 bay closed onto a short circuit between phases B and C. Time diagrams are shown on the picture 10 and trip log extract on picture 11.

The time diagrams show 180 degrees angle between currents in the faulty phases while the current in the healthy phase is below nominal value. Као што се са дијаграма види струје у фазама у квару су у контрафази, док је струја у здравој фази незнатна. At the same time voltage between shorted phases decreased and neutral point voltage reached roughly nominal phase to ground value. Picture 11 shows trip log extract from the transformer bay K04 protection relay for this event. It can be seen that the feeder relay sent a signal to the transformer relay in order to lock-out the busbar protection.
