## **RECONSTRUCTION OF SUBSTATION 110/35 kV NOVI SAD 1 INTO 110/35/20 kV**

Z. Danić, Elektrovojvodina, SCG  
V. Dobranić, Elektrovojvodina, SCG  
L. Rehak, Elektrovojvodina, SCG  
Ž. Spoja, Elektrovojvodina, SCG

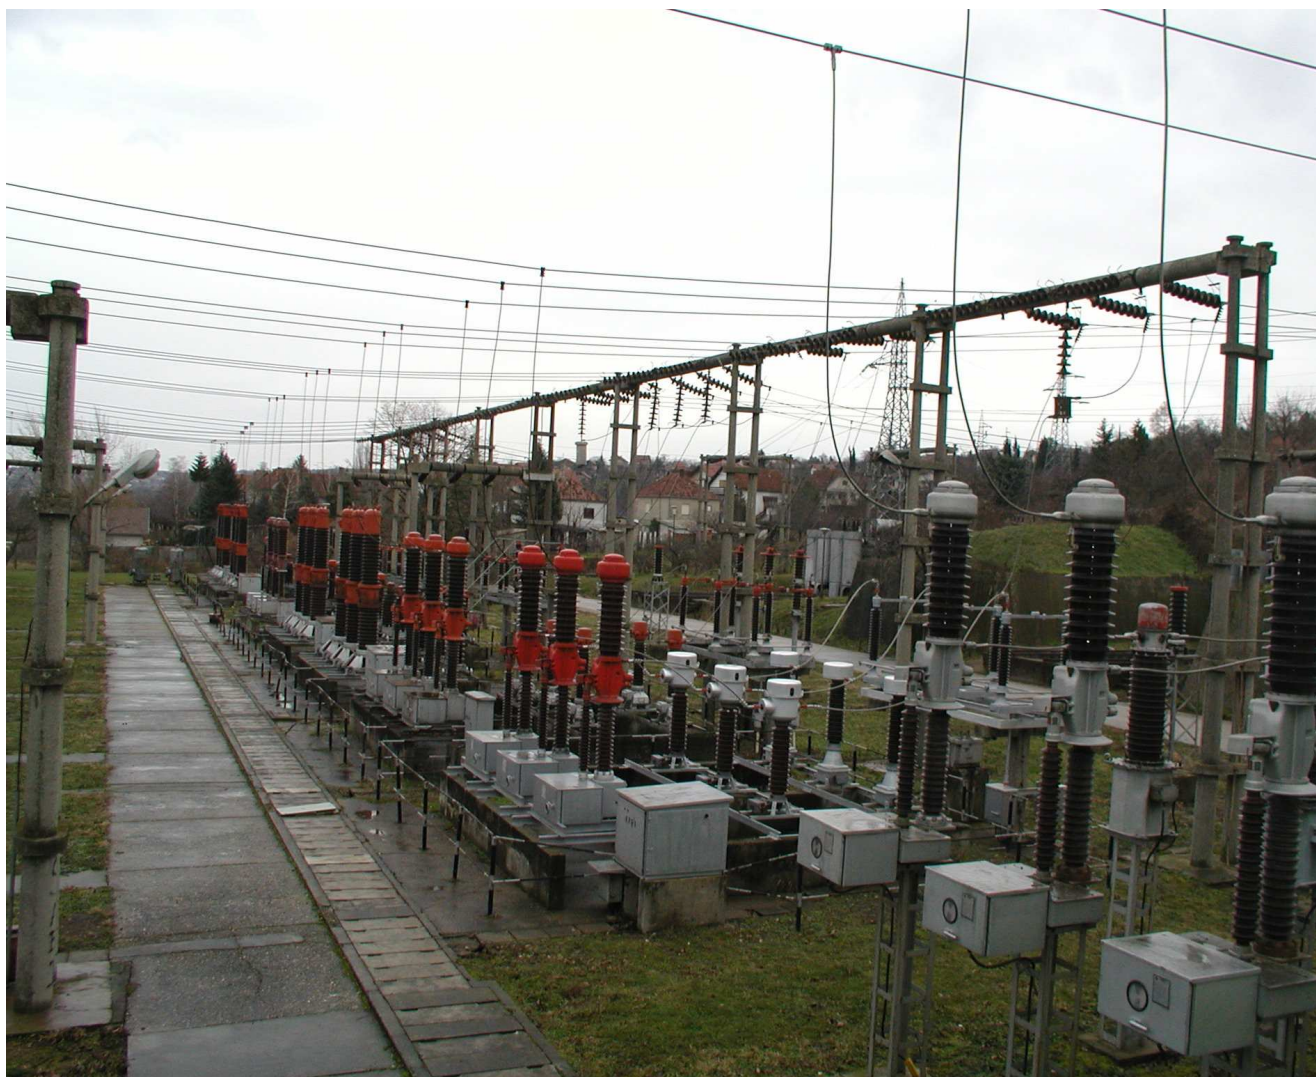
Figure 1 - Switchyard 110 kV before reconstruction

Several photos show a lot of reasons for reconstruction. Each and every part of this substation was reconstructed because everything was damaged. Concrete poles and foundation of the portals were in very bad condition. Bases of the HV apparatus made of steel were rusty. Also, each electro equipment was out-of-date, especially conductors 150 mm<sup>2</sup> made of copper and insulators made of porcelain. Meanwhile, there was a need for more reliability and capacity.

As mentioned, each 110kV equipment was out-of-date, in a very bad condition and without possibility for remote control. Only one of five transmission lines "D -1" was built with a new equipment (1993. god.).

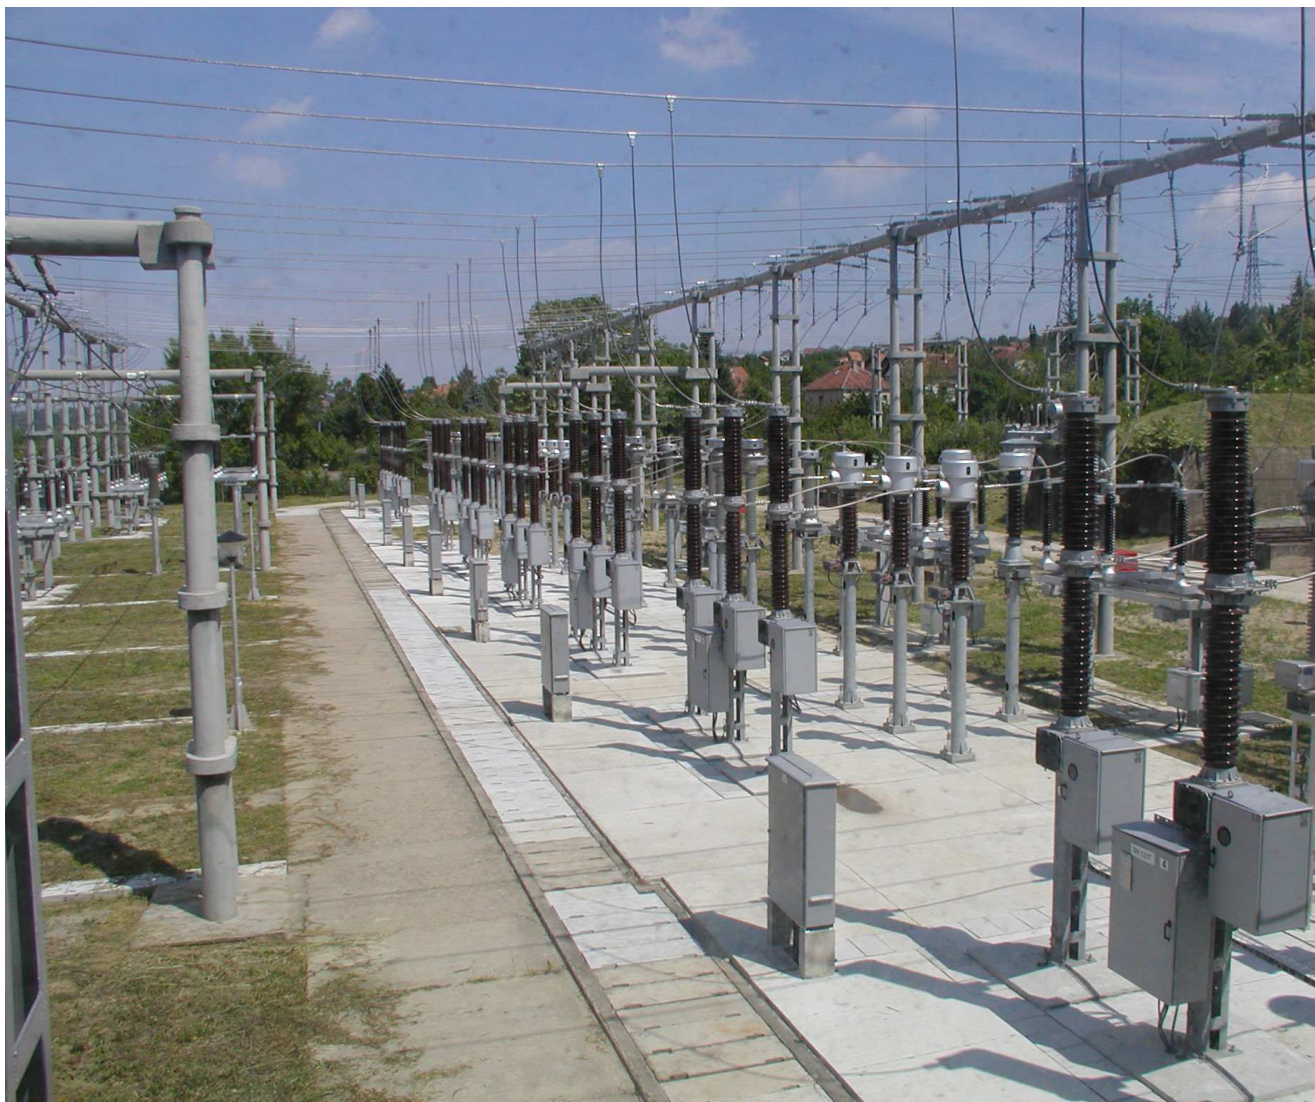
Figure 2 - Switchyard 110 kV after reconstruction

Reconstruction started in the beginning of april in 2005. First of all, substation 35kV and transformer sections 110 kV were demounted. In switchyard 110 kV foundation and supporters of circuit breakers and measuring transformers were crushed and new ones were built. Then, new grounding system and manholes for each section were built. Every time when activities on structures were finished in some section, electricians continued their work in that section.

After that, equipment 110kV was replaced by new one, new secondary LV cables were laid inside the existing main manhole which had enough space to receive all of them including existing old cables. New power transformer 110/20kV and repaired power transformer 110/35 kV were placed. New 35kV and 20kV cables between power transformers and building were laid.

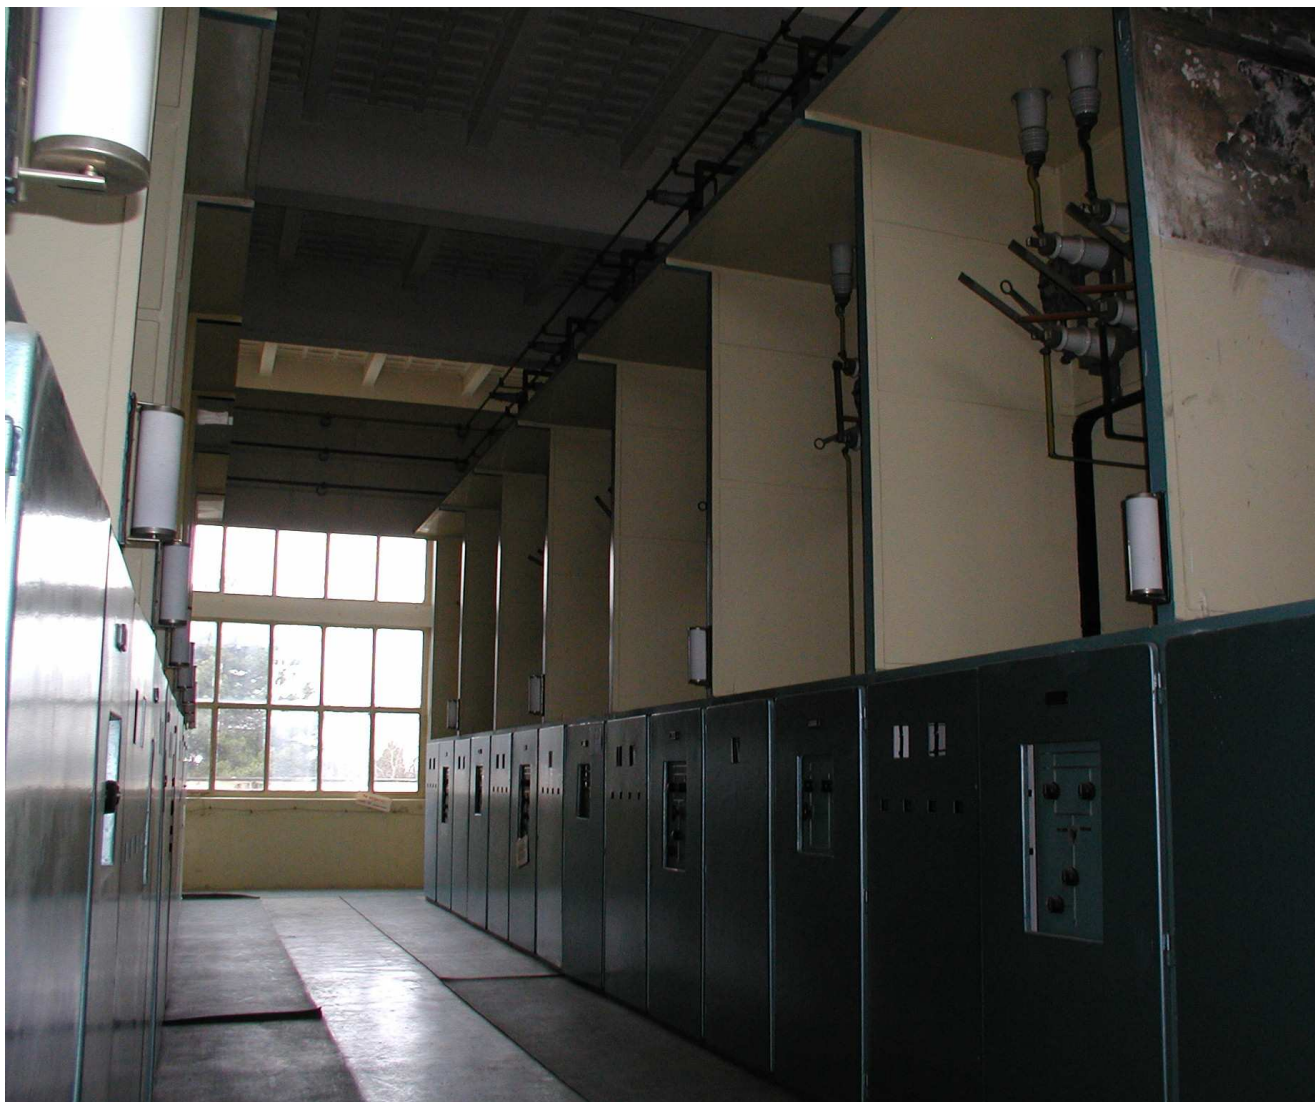
Figure 3 - Switchgear 35 kV before reconstruction

Substation 35kV was located inside the building and it had out-of-date equipment, as well. Circuit breakers 35kV with air compressed drive were produced by "Magrini", Italy and for their operation, installation with compressed air located in basement was used.

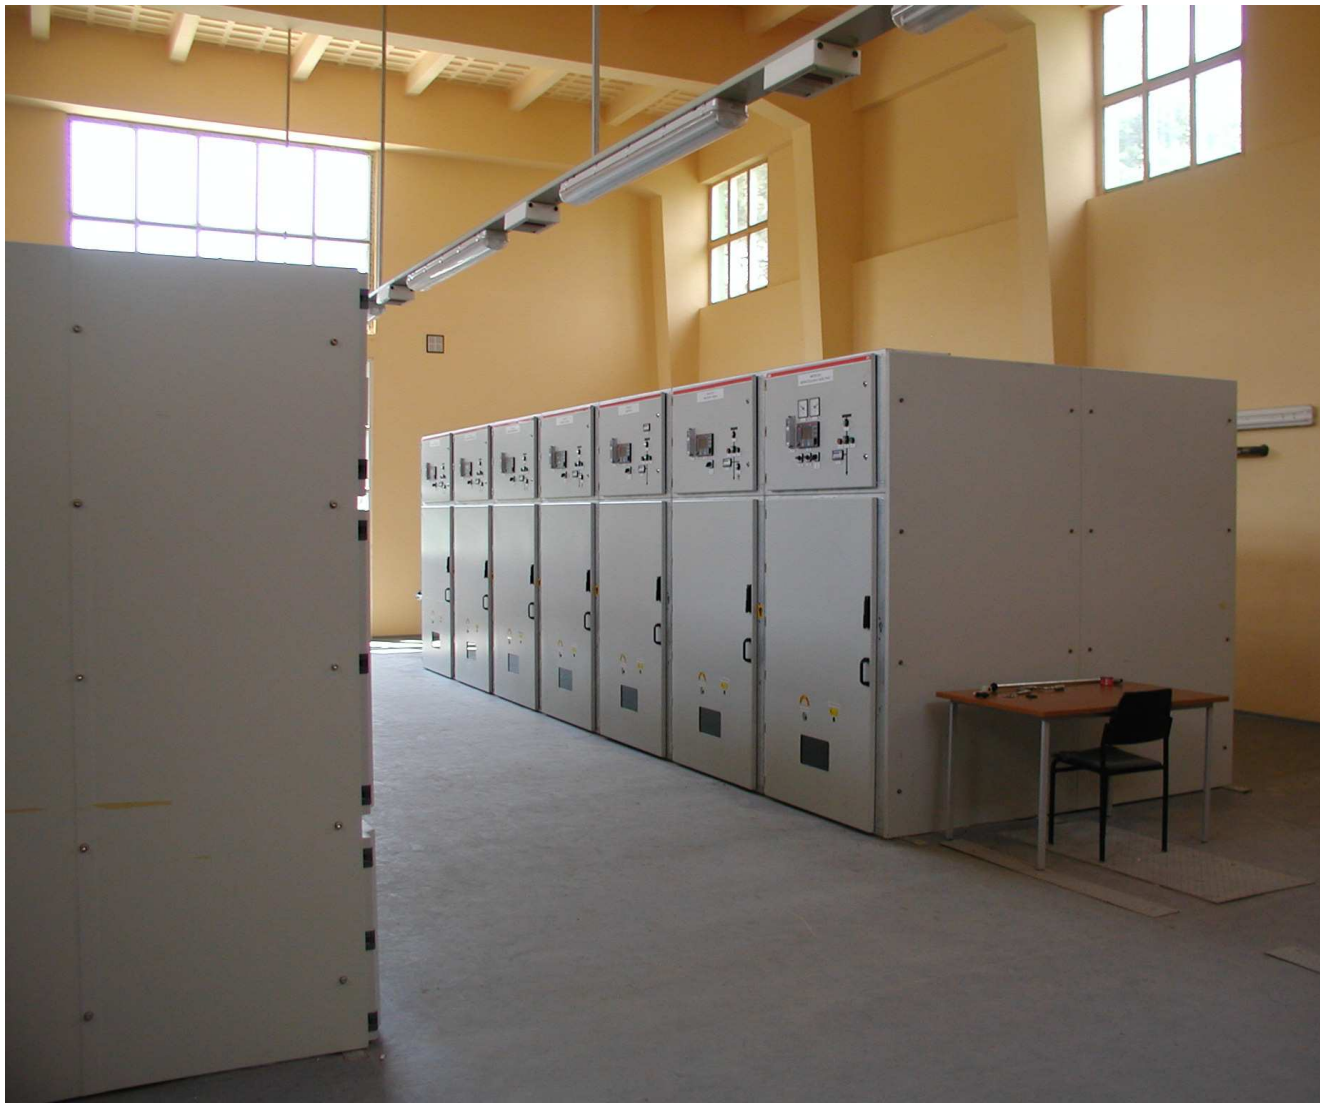
Figure 4 - Metal clad switchgear after reconstruction

Electrical instalations inside the building were completely repaired, as well as, walls and floor. Also, old windows were replaced and doors were renewed. In order to bring inside the building metal clad switchgears 20kV and 35kV, the door on the first floor were mounted.
